Sulphur Bank Mercury Mine Superfund Site

January 14, 2020

Presentation Overview

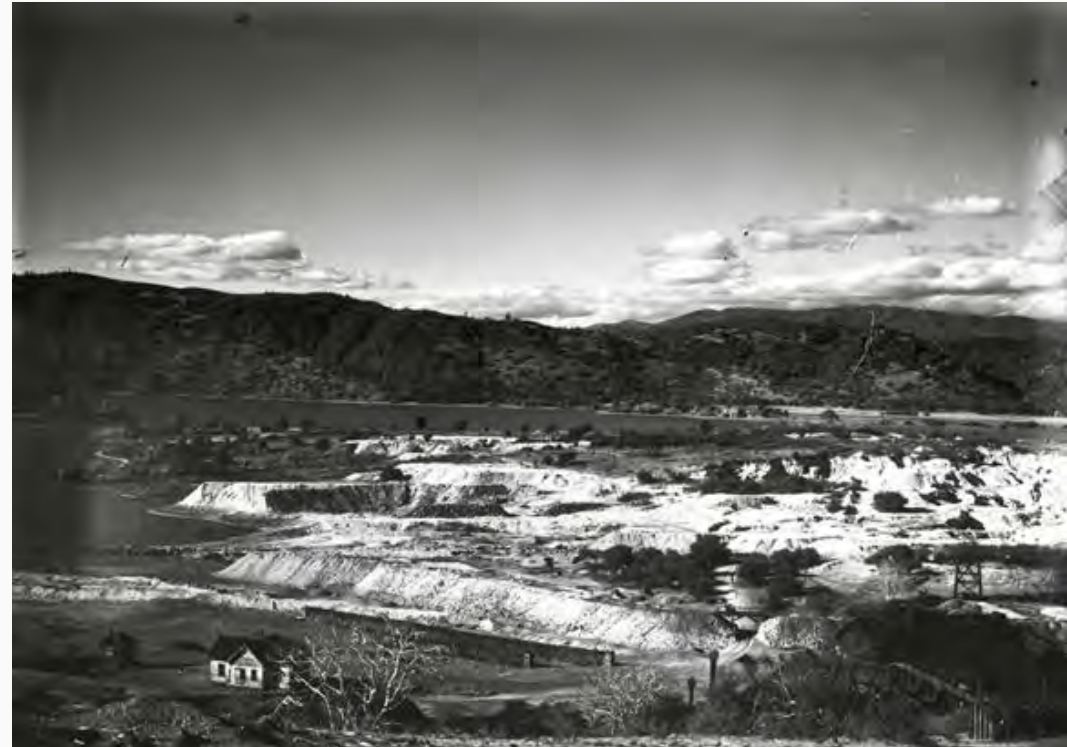
Terrestrial Mine Site and Residential Soils

Operable Unit 1

Lake Sediments and North Wetlands

Operable Unit 2

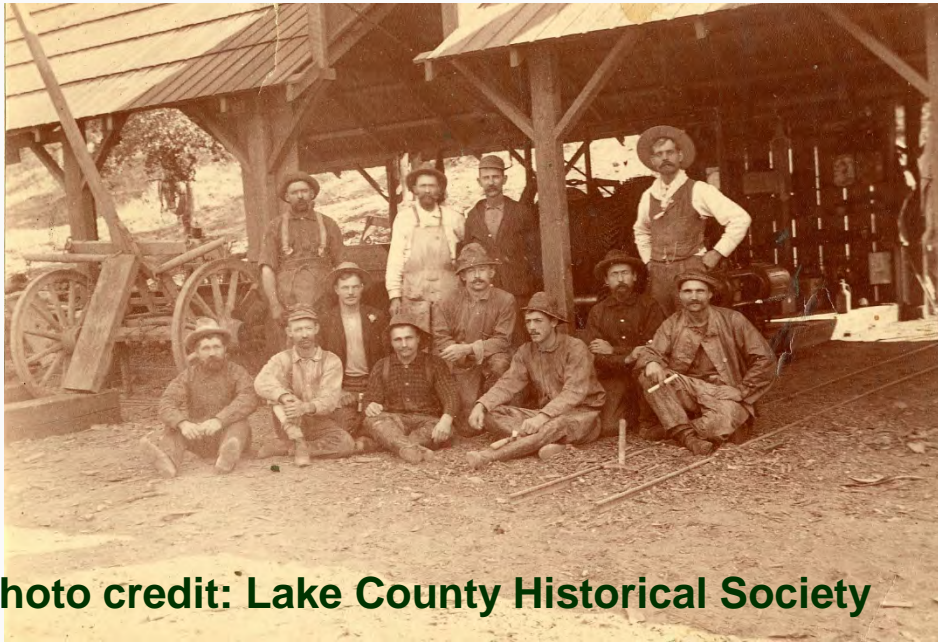
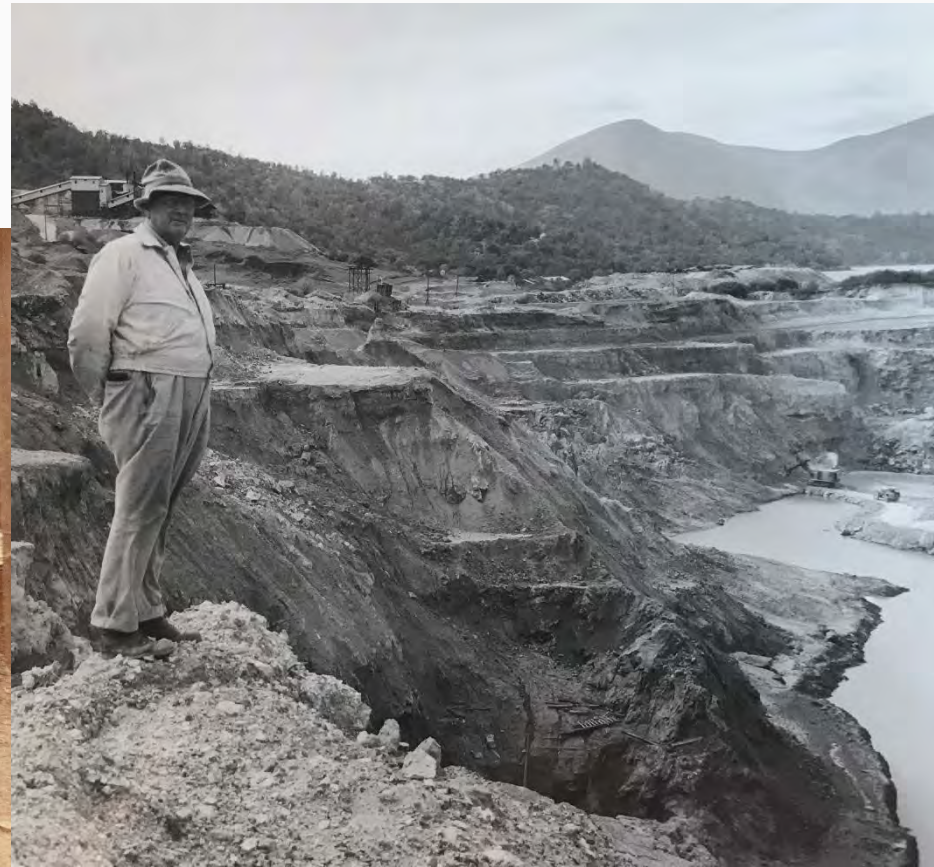
- Sulphur Bank Mine operated from 1856 to 1957.
 - First borax, then sulfur, then shifting to mercury in 1873
 - Shallow underground tunnels and open pit operations
 - Cinnabar ore processed on-site
 - Bradley Mining Corp identified as the responsible party

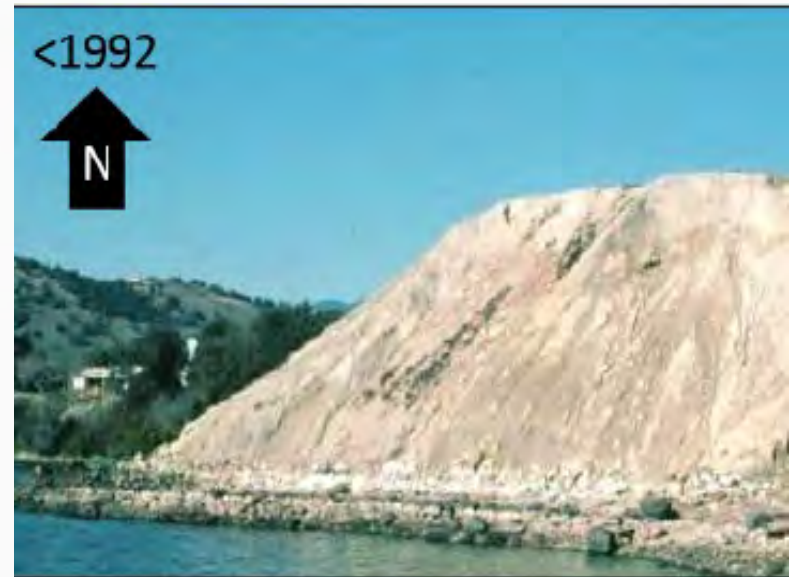
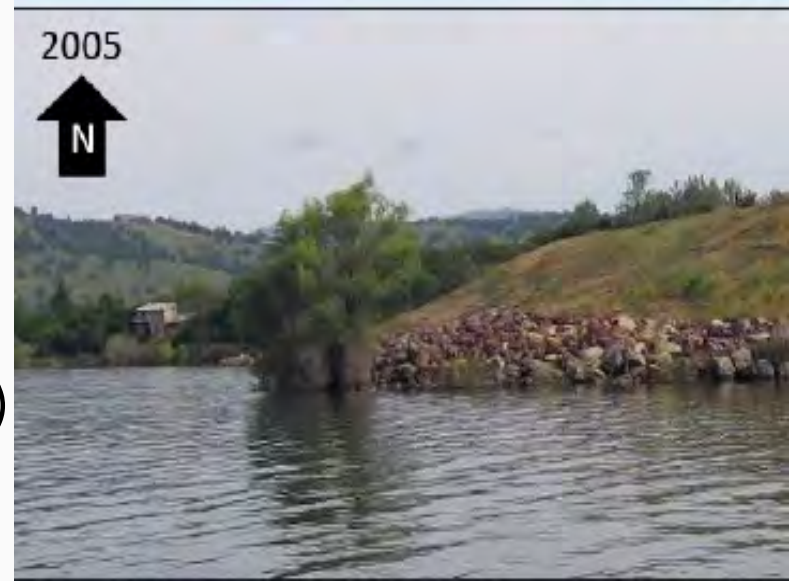
- Site Controls (1990)
- Removal of soils, replacement of homes and infrastructure on Elem Indian Colony (1997,1998,2006)
- Geothermal well closures (2000-2001)
- Removal of soils from Sulphur Bank Mine Road residential area (2008)
- Pomo Road cleanup (2010)

- Stabilization of Waste Rock Dam (1992)
- Stormwater Diversion/Pipeline (1999-2000)
- Sediment test caps in Clear Lake (2012-2016)
